Diamond Hills Stream Restoration

Town of Christiansburg, Virginia

CONCEPT PLAN NARRATIVE

Diamond Hills
Stream Restoration
Concept Plan
Christiansburg, Virginia

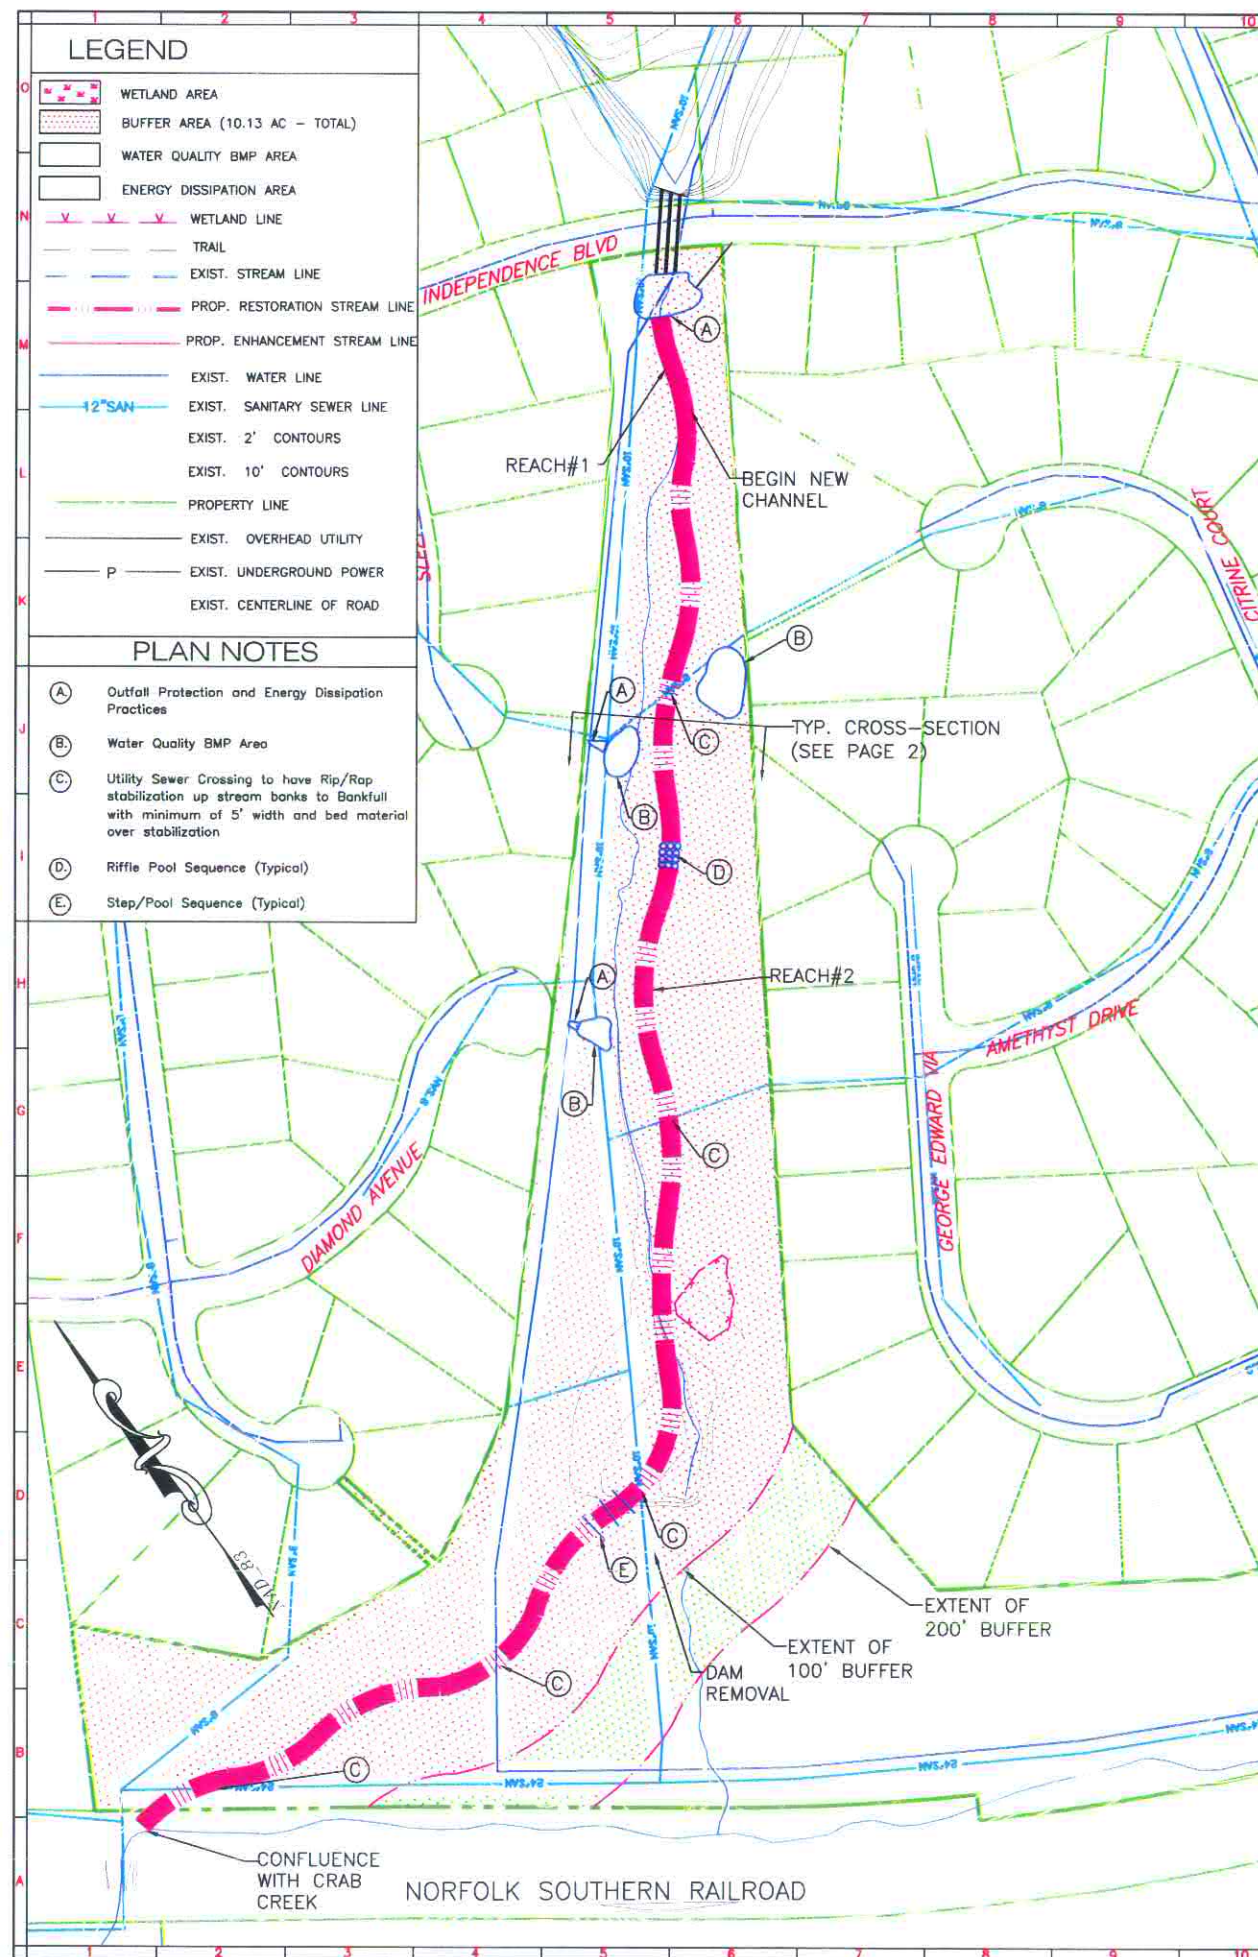
SHEET NO.
1 of 2
JOB NO. B1000031.00

- Project Description:** The project team is proposing stream restoration activities on approximately 2,180 linear feet of an unnamed tributary of Crab Creek resulting in 2,233 linear feet of restored stream. The tributary is located within Diamond Hills, a residential subdivision, and it receives stormwater runoff from this subdivision, commercial properties, and town properties located within the contributing watershed totaling approximately 514 acres. The project site can be accessed from Independence Blvd. off of North Franklin St. (Rt. 460) in Christiansburg, Virginia.

- Existing Conditions:** The 514 acre drainage area is highly urbanized with residential, commercial, and industrial land uses. The land surrounding the unnamed tributary of Crab Creek and adjacent to Crab Creek is predominately open grassland with sparse trees consisting primarily of Black Willow, Box Elder, Catalpa, and Black Cherry along the stream banks. The stream is highly unstable evidenced by channel incision up to six feet, vertical bank walls, active bank erosion, deleterious debris, and sedimentation among other impacts. Instream habitat is degraded or non-existent due to sediment loading, channel instability (i.e. bank failure, high velocity flows, rapidly changing channel pattern or profile, etc.), and lack of woody debris. There are multiple sanitary sewer crossings downstream of Independence Blvd. and a stormwater management facility including a vegetated dam and culverts. The stream receives runoff from overland flow and both vegetated and rip rap outlets.

- Conceptual Restoration Description:** All restoration activities proposed are based on Natural Channel Design Principles.
 - Channel Alteration:** The profile, pattern, and cross-section of reaches 1 & 2 shall be altered to address stability issues. A riffle/pool sequence shall be utilized based on present conditions and current design research and practices. Rock Cross Vanes and other step/pool practices shall be utilized where applicable. The new cross-section and bed elevation adjustments will re-connect the stream to its historic floodplain. The bed shall be reinforced with a minimum of 1' depth to prevent incision and control grade throughout the stream. Habitat structures shall be installed where appropriate and reduced sediment loading, proper substrate, and reduced volume and velocities from storm events will increase ecological diversity within the stream. The section of Crab Creek that is located adjacent to the property, Reach 3, can be restored or enhanced with buffer plantings and bank slope modifications in the future. The existing stream approximately 150' below Independence Blvd. shall be abandoned and filled with compacted soil and stone.

- Dam & Stormwater Management Facility:** The dam and stormwater culvert shall be removed to allow for a natural channel design to be implemented. The stream shall be routed to intersect Crab Creek at a less severe angle and reduce the damaging effect of large storm events to the railroad embankment. Storage capacity will be maintained through a series of smaller detention/engineered wetland areas to control storm events.
